### BULLETIN

## Clunking noise from under vehicle

Dodge Dakota and Durango 1997-2004;  
Jeep Wrangler 2000-2006

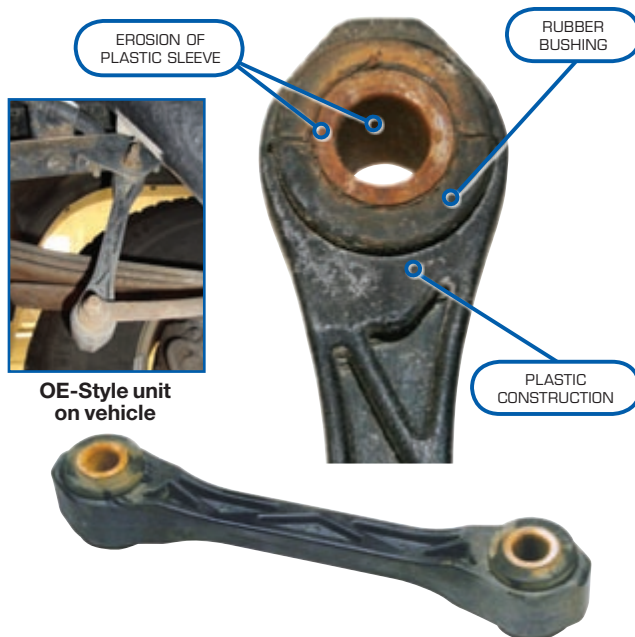
#### Clunking noise from underneath rear of vehicle

When going over bumps or washboard surfaces, drivers of Jeep Wranglers, Dodge Dakotas and Dodge Durangos may experience clunking and/or banging noise from underneath the rear of the vehicle. The cause is failure of the rear sway bar link. The OE-style link is prone to failure on these vehicles, especially in northern climates where more salt, road grit and grime are present. These contaminants can get into the bushing and erode the plastic sleeve, causing it to elongate and become loose, which creates noise.
