Installation Instructions

For set # 8.3145
 2007-21 TOYOTA TUNDRA
 2008-22 TOYOTA SEQUOIA
 2008-21 TOYOTA LAND CRUISER
 2008-21 LEXUS LX 570

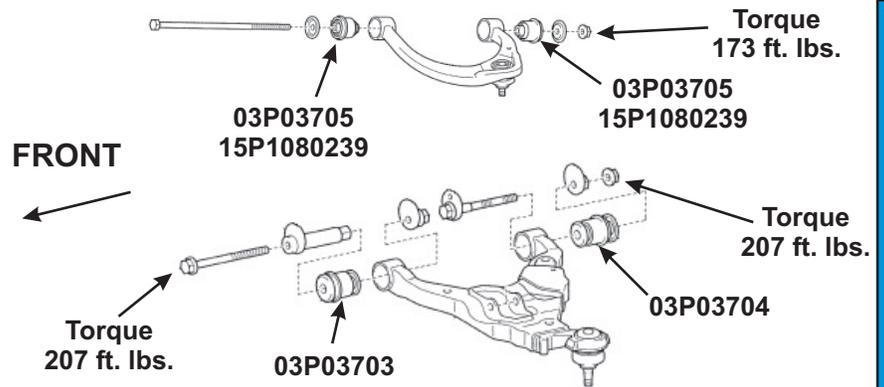
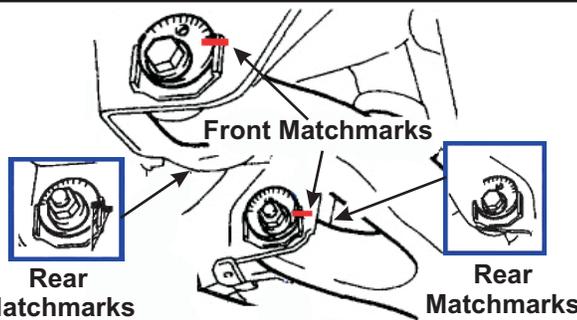
Be sure to place matchmarks on the front and rear adjusting cams before you start. You will need to use these matchmarks to reinstall the lower control arms back in the same position after the new polyurethane bushings are installed. Torque to 129 ft. lbs. Then have the vehicle's alignment checked by a certified technician. The alignment must be within factory specifications.

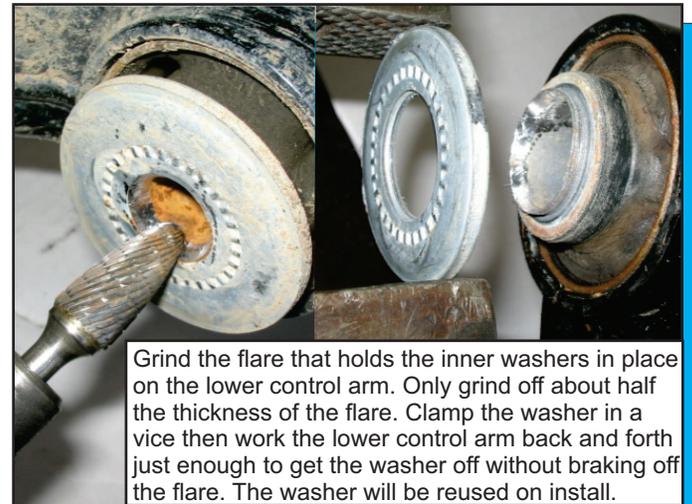
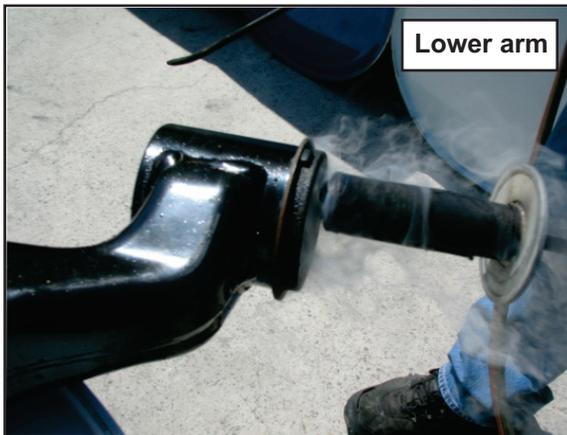
Do not remove the factory metal shells from the lower control arms, they must be reused. The inner metal sleeves and washers on the lower control arm must be reused. To remove the old rubber from the factory shells and inner sleeves, apply light heat evenly around the outside of the control arm outer metal shell, just enough to brake the bond with the rubber. Do the same on the inside of the sleeves on the lower control arms. When you see light smoke coming from the sides of the bushing the bond should be broken. At no time should there be any flames coming from the rubber. If there are any flames, back off with the heat. When melted, just push the old rubber and inner metal sleeve out. Let the outer metal shells and sleeves cool off before cleaning. Use a wire brush to remove any remaining old rubber. File off any sharp edges that will contact the new polyurethane bushings.

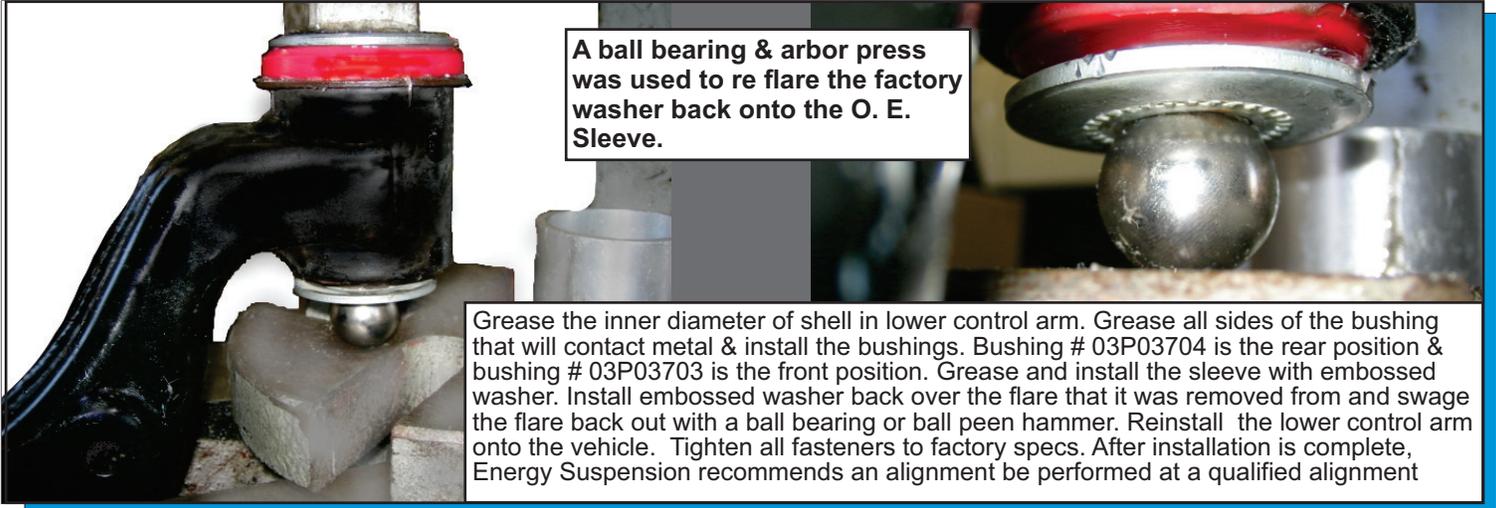
A ball bearing & arbor press was used to re flare the factory washer back onto the O. E. Sleeve.

Grease the inner diameter of shell in lower control arm. Grease all sides of the bushing that will contact metal & install the bushings. Bushing # 03P03704 is the rear position & bushing # 03P03703 is the front position. Grease and install the sleeve with embossed washer. Install embossed washer back over the flare that it was removed from and swage the flare back out with a ball bearing or ball peen hammer. Reinstall the lower control arm onto the vehicle. Tighten all fasteners to factory specs. After installation is complete, Energy Suspension recommends an alignment be performed at a qualified alignment

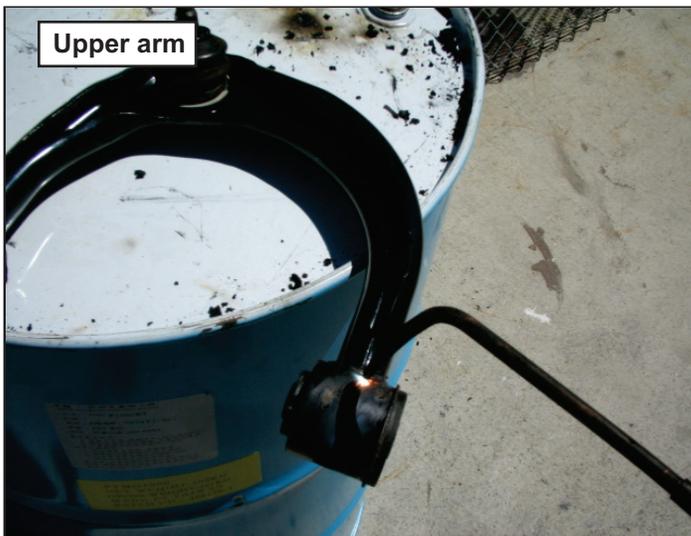
Upper arm

Do not remove the factory metal shells from the upper control arms, they must be reused. New inner metal sleeves are supplied for the upper control arms. To remove the old rubber from the factory shells and inner sleeves, apply light heat evenly around the outside of the control arm, just enough to brake the bond with the rubber. When you see light smoke coming from the sides of the bushing, the bond should be broken. At no time should there be any flames coming from the rubber. If there are any flames, you need to back off with the heat. After the bond is broken, push the old rubber and inner metal sleeve out. Let the outer metal shells and sleeves cool off before cleaning.

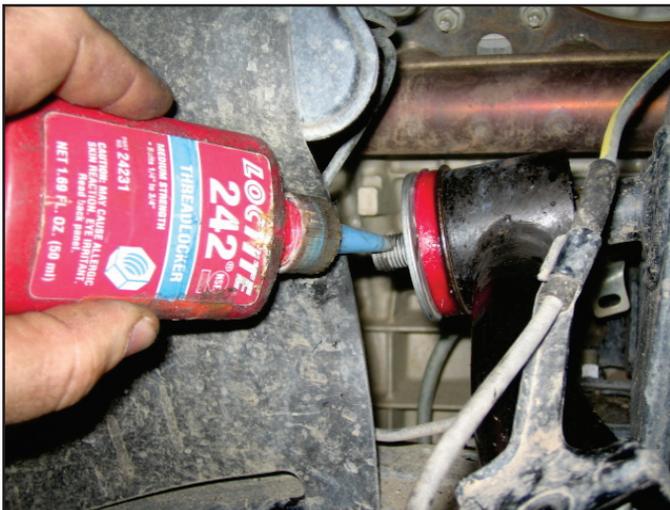
Use a wire brush to remove any remaining old rubber. File off any sharp edges that will contact the new polyurethane bushings. Apply grease to all metal parts that contact the polyurethane bushings. Apply thread locking compound to upper control arm through bolt then torque to 173 ft. lbs.
