**BULLETIN: 210006**

## Rear Suspension Pivot Bushing Failure

**GM Crossovers  
and Minivans**

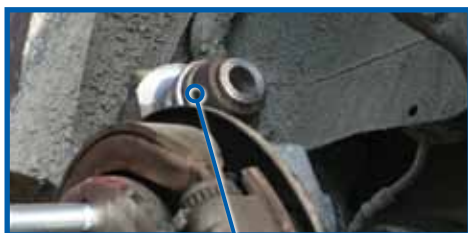
PIVOT BUSHING

GM crossover and minivan rear aluminum suspensions use a "cross-axis" pivot bushing which is pressed into the upper axle/hub carrier (or knuckle). This pivot bushing takes the place of an upper ball joint. The OE part may experience early failure, creating rear alignment change which can lead to excessive tire wear. In addition, this part is not available separately from the dealer. If the bushing is worn or failed, the entire axle/hub carrier must be replaced.

Cross axis pivot bushing unassembled

The MOOG K200174 and MOOG K200175 pivot bushings correct the looseness and restore alignment integrity. The lower pivot bushing K200175 is a companion part suggested to be changed when the upper pivot bushing is replaced. Since these parts are available separately, the OE axle/hub carrier (knuckle) can be retained.

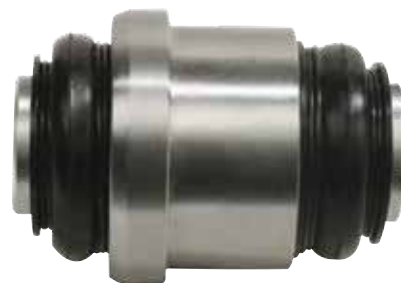
MOOG K200174 upper pivot bushing

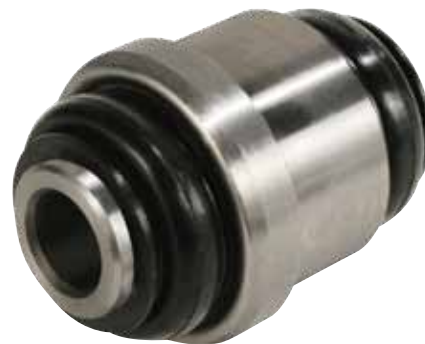
MOOG K200175 lower pivot bushing
