Installation Instructions

Set No. 7.3123

Front Lower Control Arm Bushings
2010-2013 Nissan Altima Base, S, SL,
SR

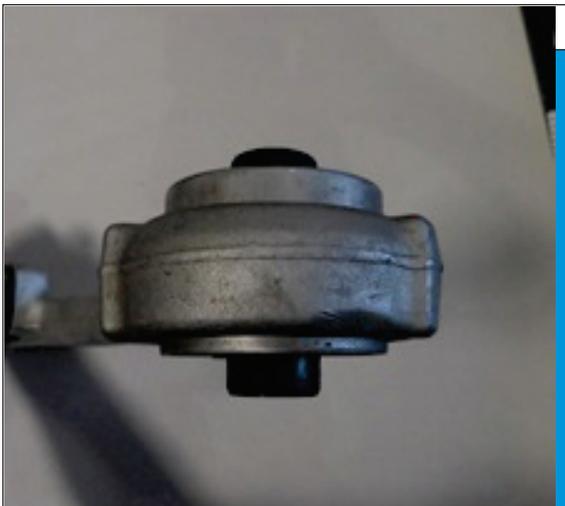
Take note of the orientation of the OEM bushings in the Lower Control Arm and be sure to install the new bushings and sleeves in the same orientation. The new bushings are designed with a thicker flange on one side to achieve the OEM placement of the Control Arm on the vehicle. The thicker flange goes on the top side of the control arm for both bushing locations.

Note the OEM shell being off center in the Control Arm with a larger dimension between the top of the Control Arm and the end of the sleeve.

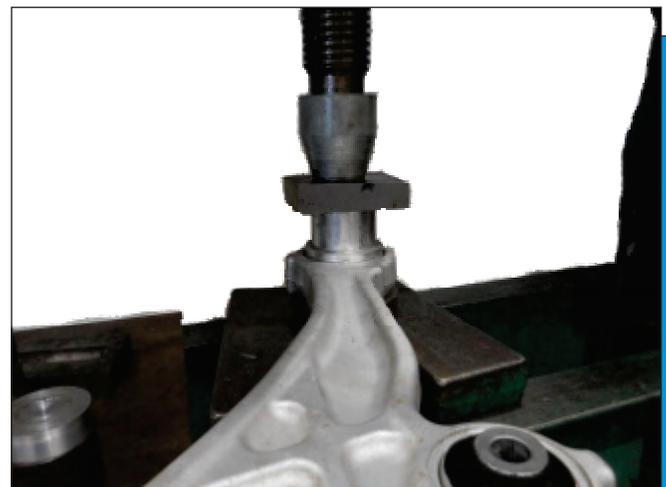
Use a hydraulic press or bench vise to remove OEM bushing and shell as shown.

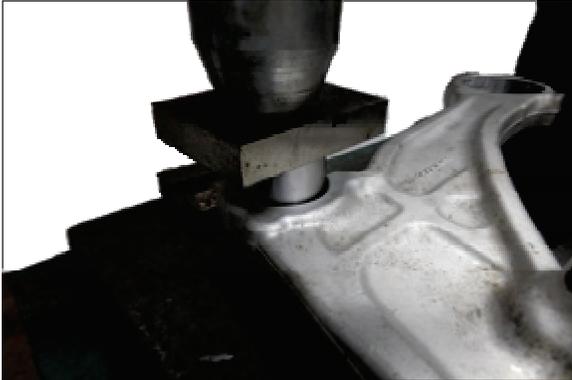
Remove the front position OEM bushing in the same manner as the rear position bushing as shown.

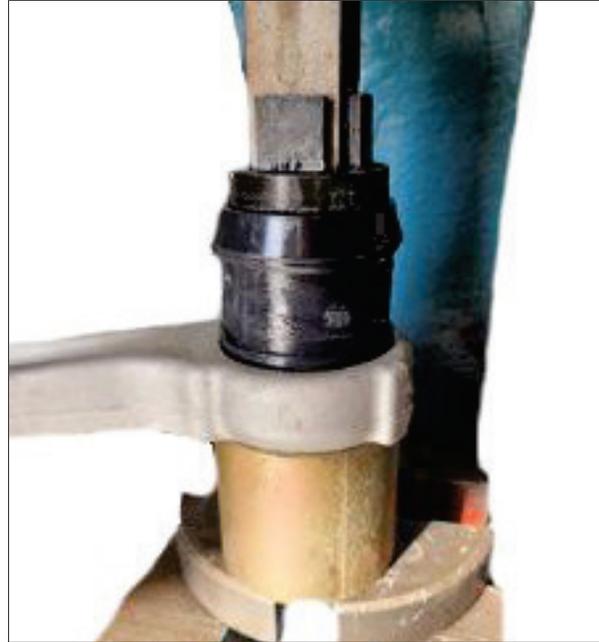
Lightly lubricate the leading edge and OD of the new Lower Control Arm Bushings (03P03675 and 03P03676). Use an Arbor Press or Bench Vise to push them into the arm. Be sure to orient the new bushings with the larger flange on the TOP side of the Control Arm.

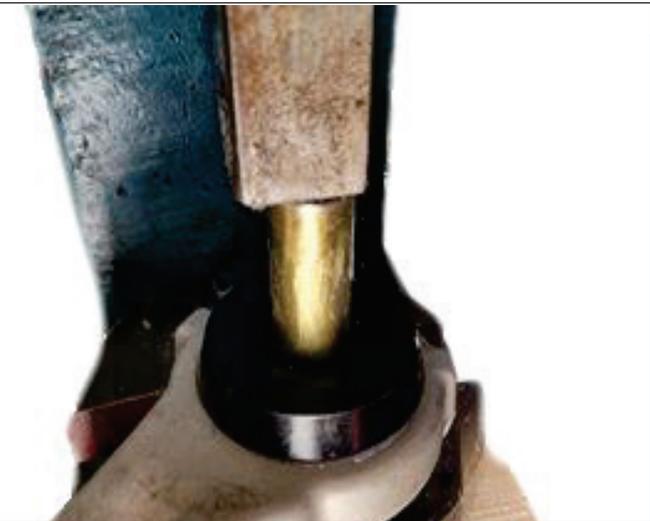
Lubricate the leading edge and OD of the new sleeves (15P10791 and 15P10795) and push them into place in the same manner as in the previous step.
