# Installation Instructions

Set No. 7.3124

Rear Suspension Bushings

2010-2013 Nissan Altima Base, S, SL,  
SR

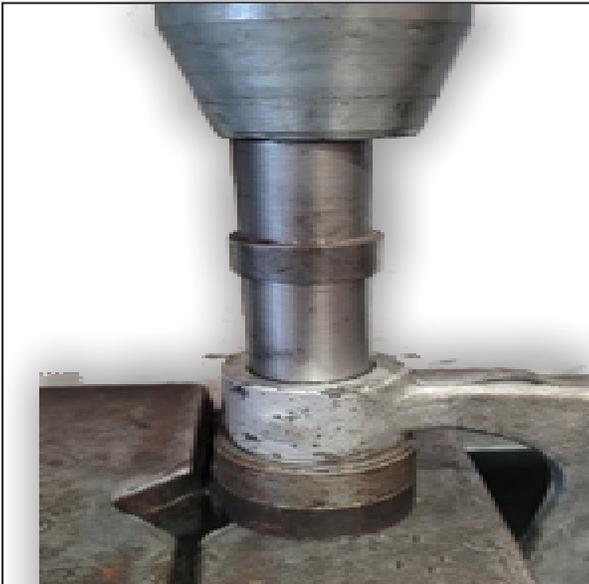
Use a hydraulic press to remove the old bushing and shell as shown. Support the upper control arm to prevent the part from falling when bushing becomes free from the arm.

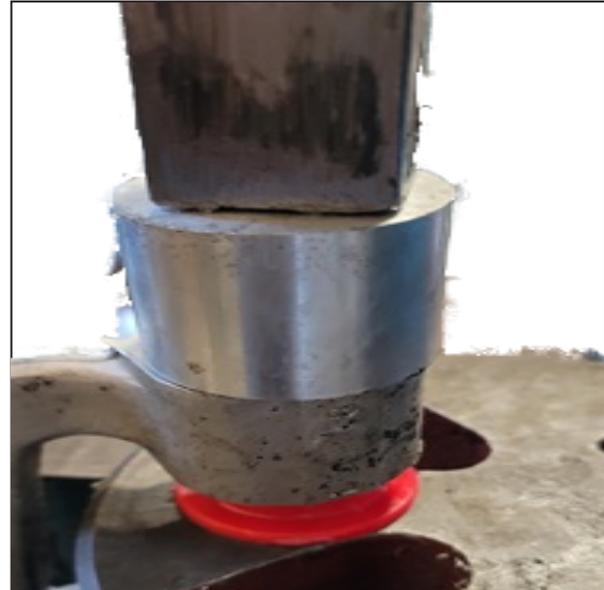
The new rear upper control arm bushings (03P03683 and 03P03684) can be lubricated and installed into the control arm using a bench vise, arbor press, or by hand in some cases as shown.

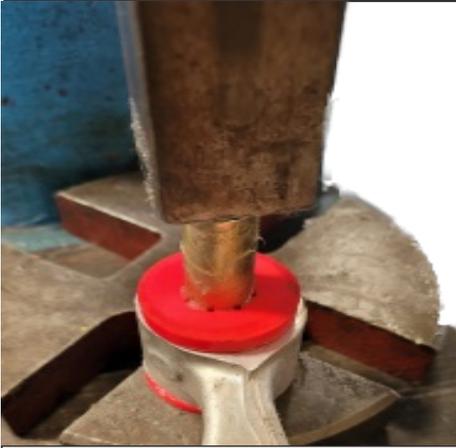
After the new control arm bushings are installed, the new sleeve (15.10.245) can be lubricated and pushed into new bushings using an arbor press or bench vise as shown.

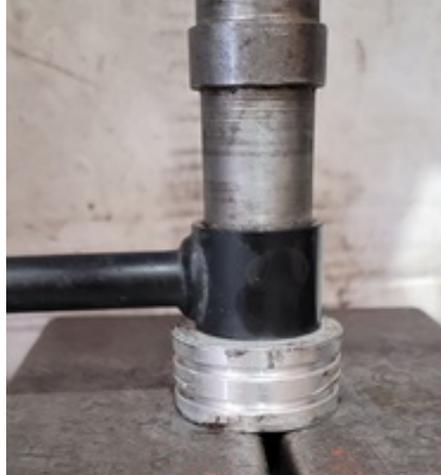
Remove old bushings from the camber link rod using a hydraulic press as shown.

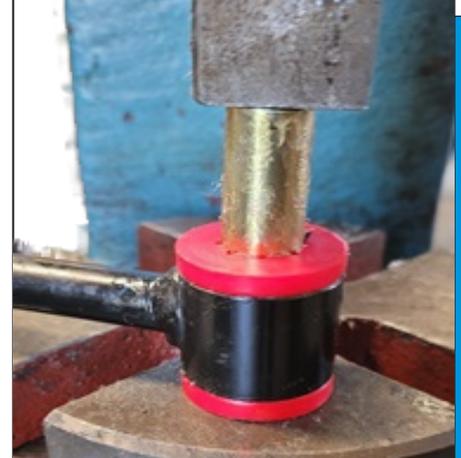
Lightly lubricate and push the new bushings (03P03682) and sleeve (15.10.155) into the eye of the Camber Link in same manner as the upper control arm.

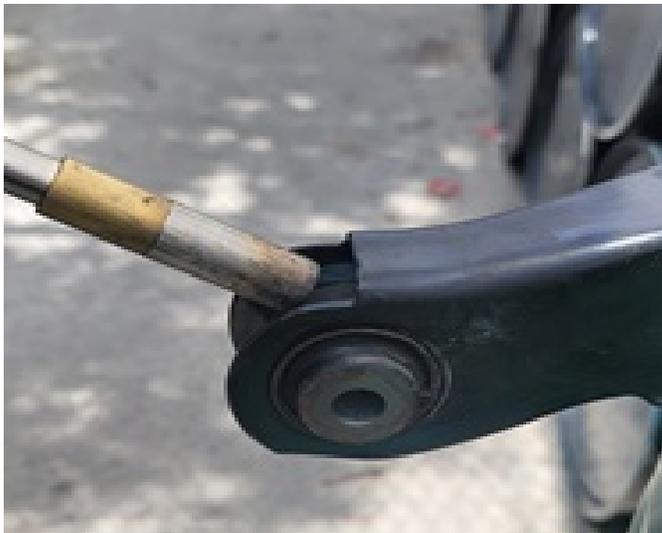
To remove the old lower control arm bushing, we recommend using a torch to heat the shell enough to break the bond between the rubber and metal.

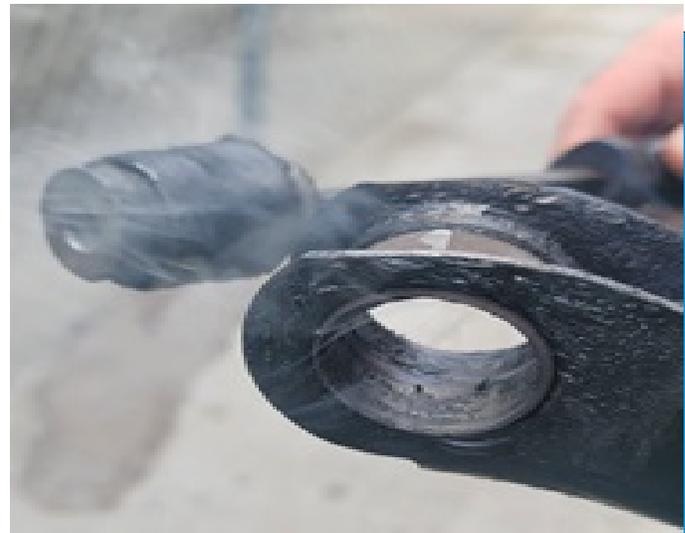
Once the bond is broken, the bushing should come out with little effort. Use caution as the bushing will be extremely hot. After the bushing is removed, clean remaining rubber fragments from the inside of the shell.

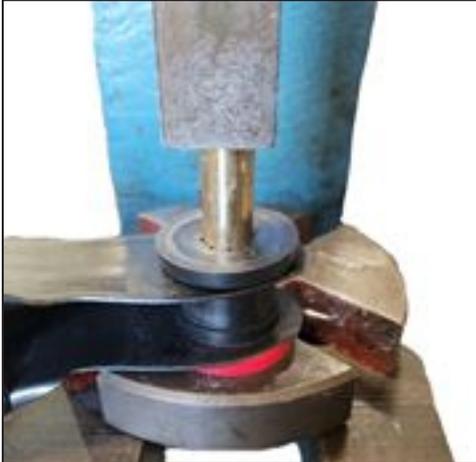
After cleaning the remaining rubber from the inside of the shell, lubricate and push the new bushings (03P03685, 03P03686) and sleeve (15.10.245) into the OEM shell.

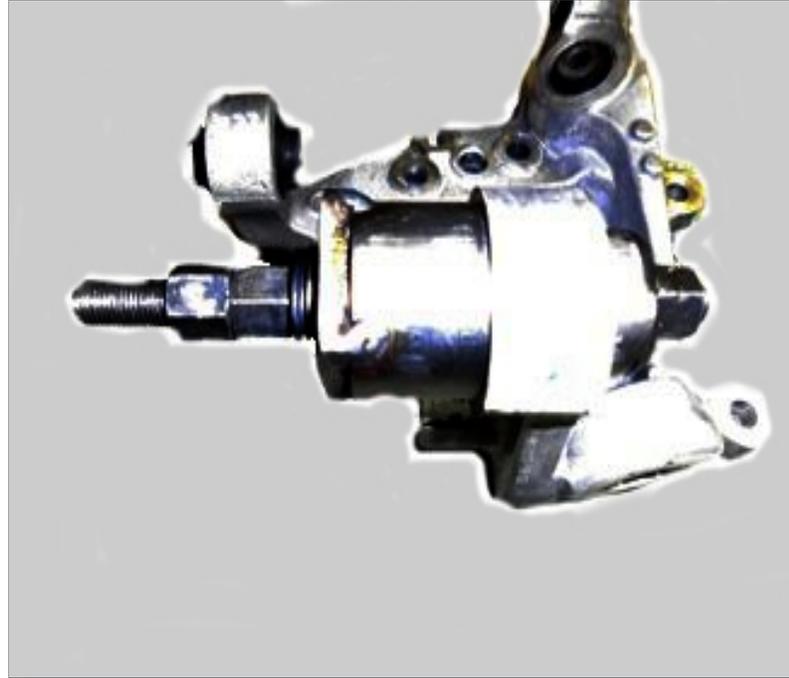
To remove factory bushings from rear Knuckle use all-thread, high nuts, flat washers and some metal tubing. The metal tubing needs to be of two different sizes. One piece slightly smaller than the OD of the OEM bushing shell and one that is larger than the ID of the bushing eye in the knuckle. Turn the nuts with wrenches to draw the old bushing and shell into the larger size tubing.
